INSTALLATION RESTORATION PROGRAM

REMEDIAL INVESTIGATION REPORT

FORBES FIELD AIR NATIONAL GUARD BASE
TOPEKA, KANSAS

OCTOBER 1989

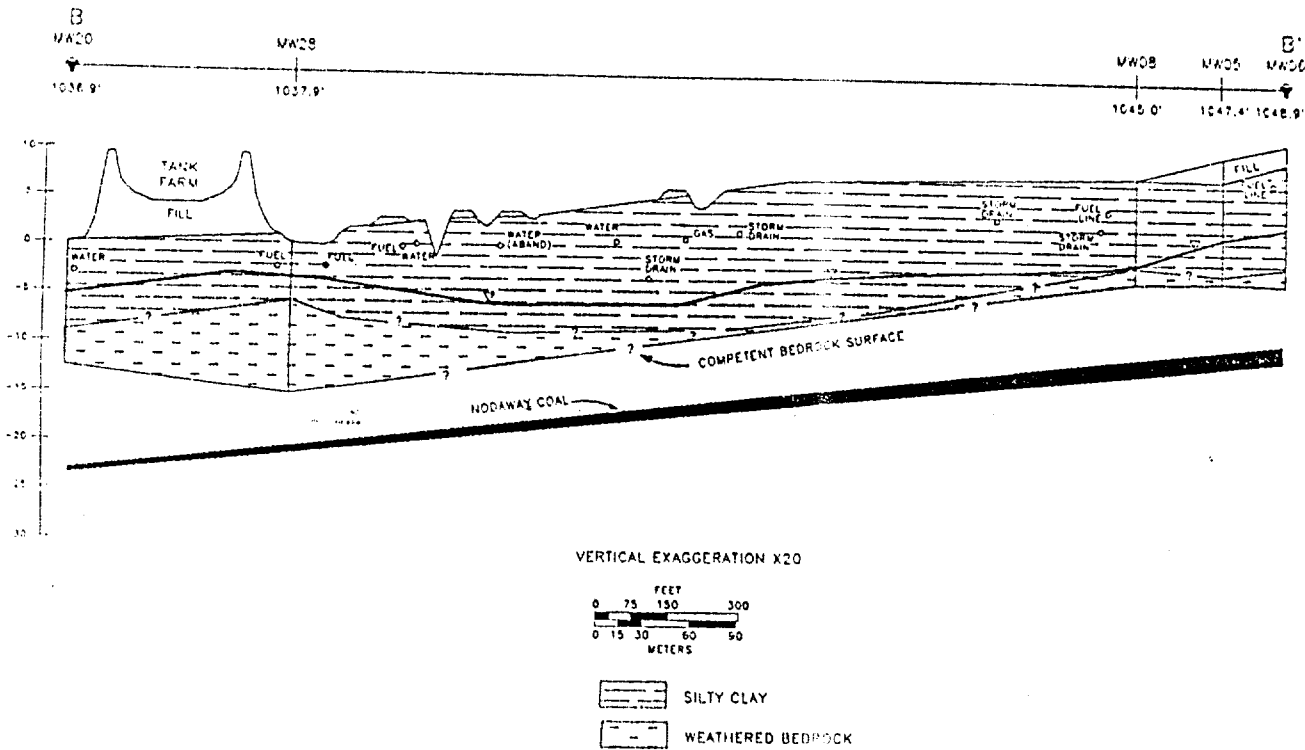
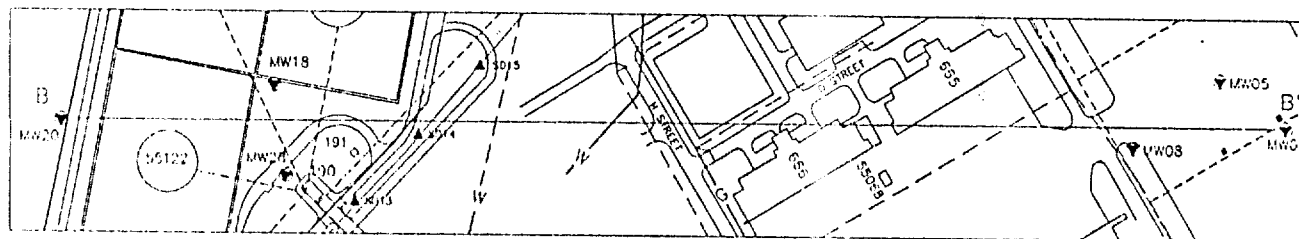
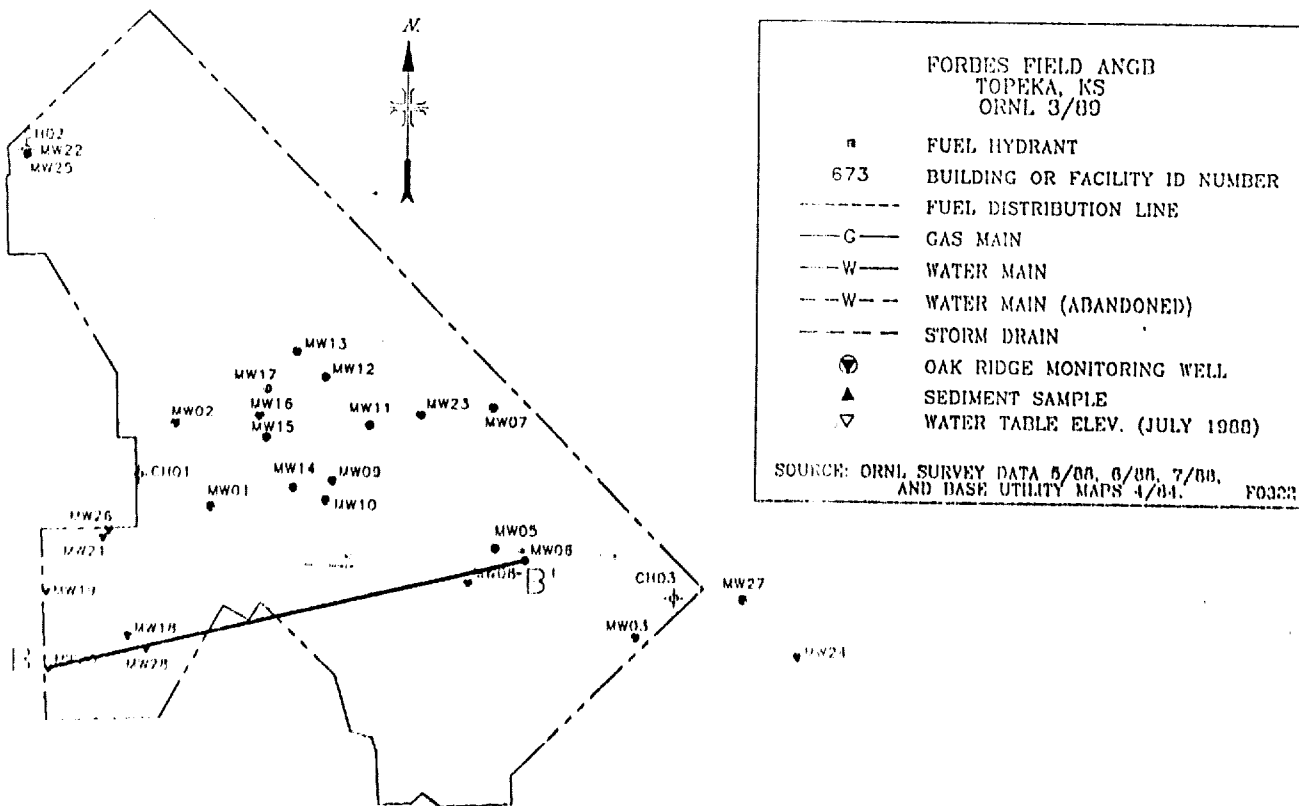
Fig. 2.10b. Cross section from MW020 to MW006.

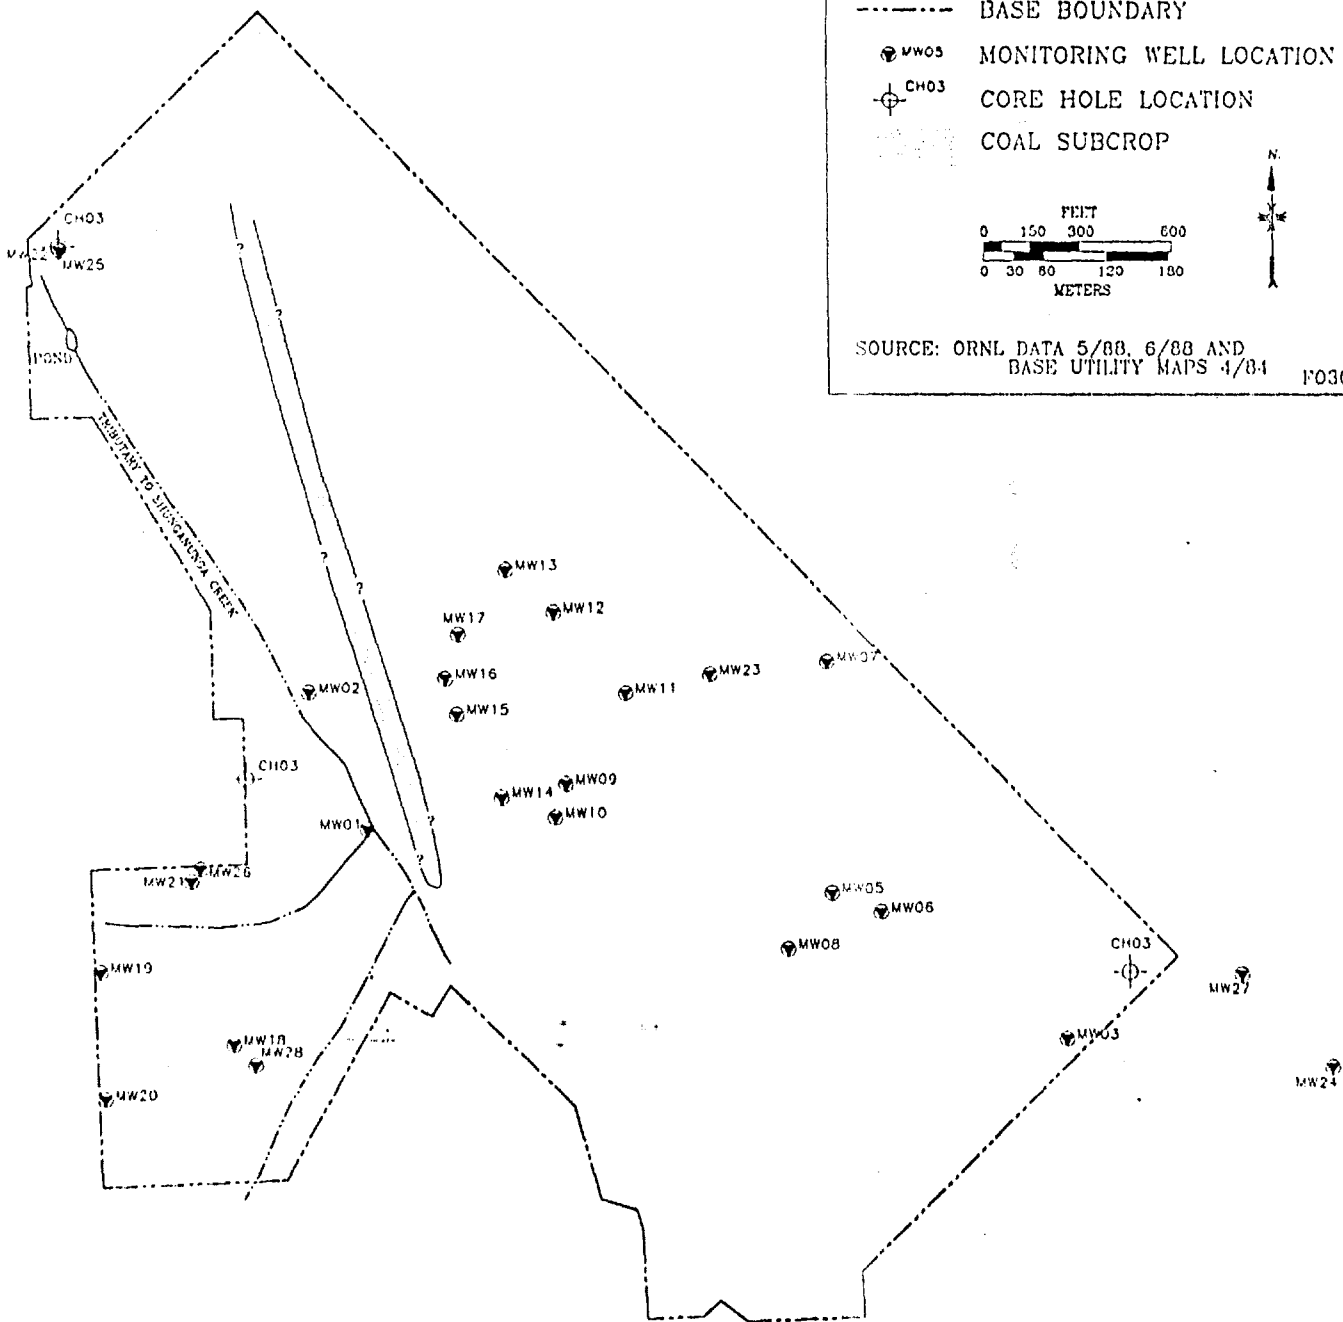
Fig. 2.11. Position of the Nodaway Coal subcrop.

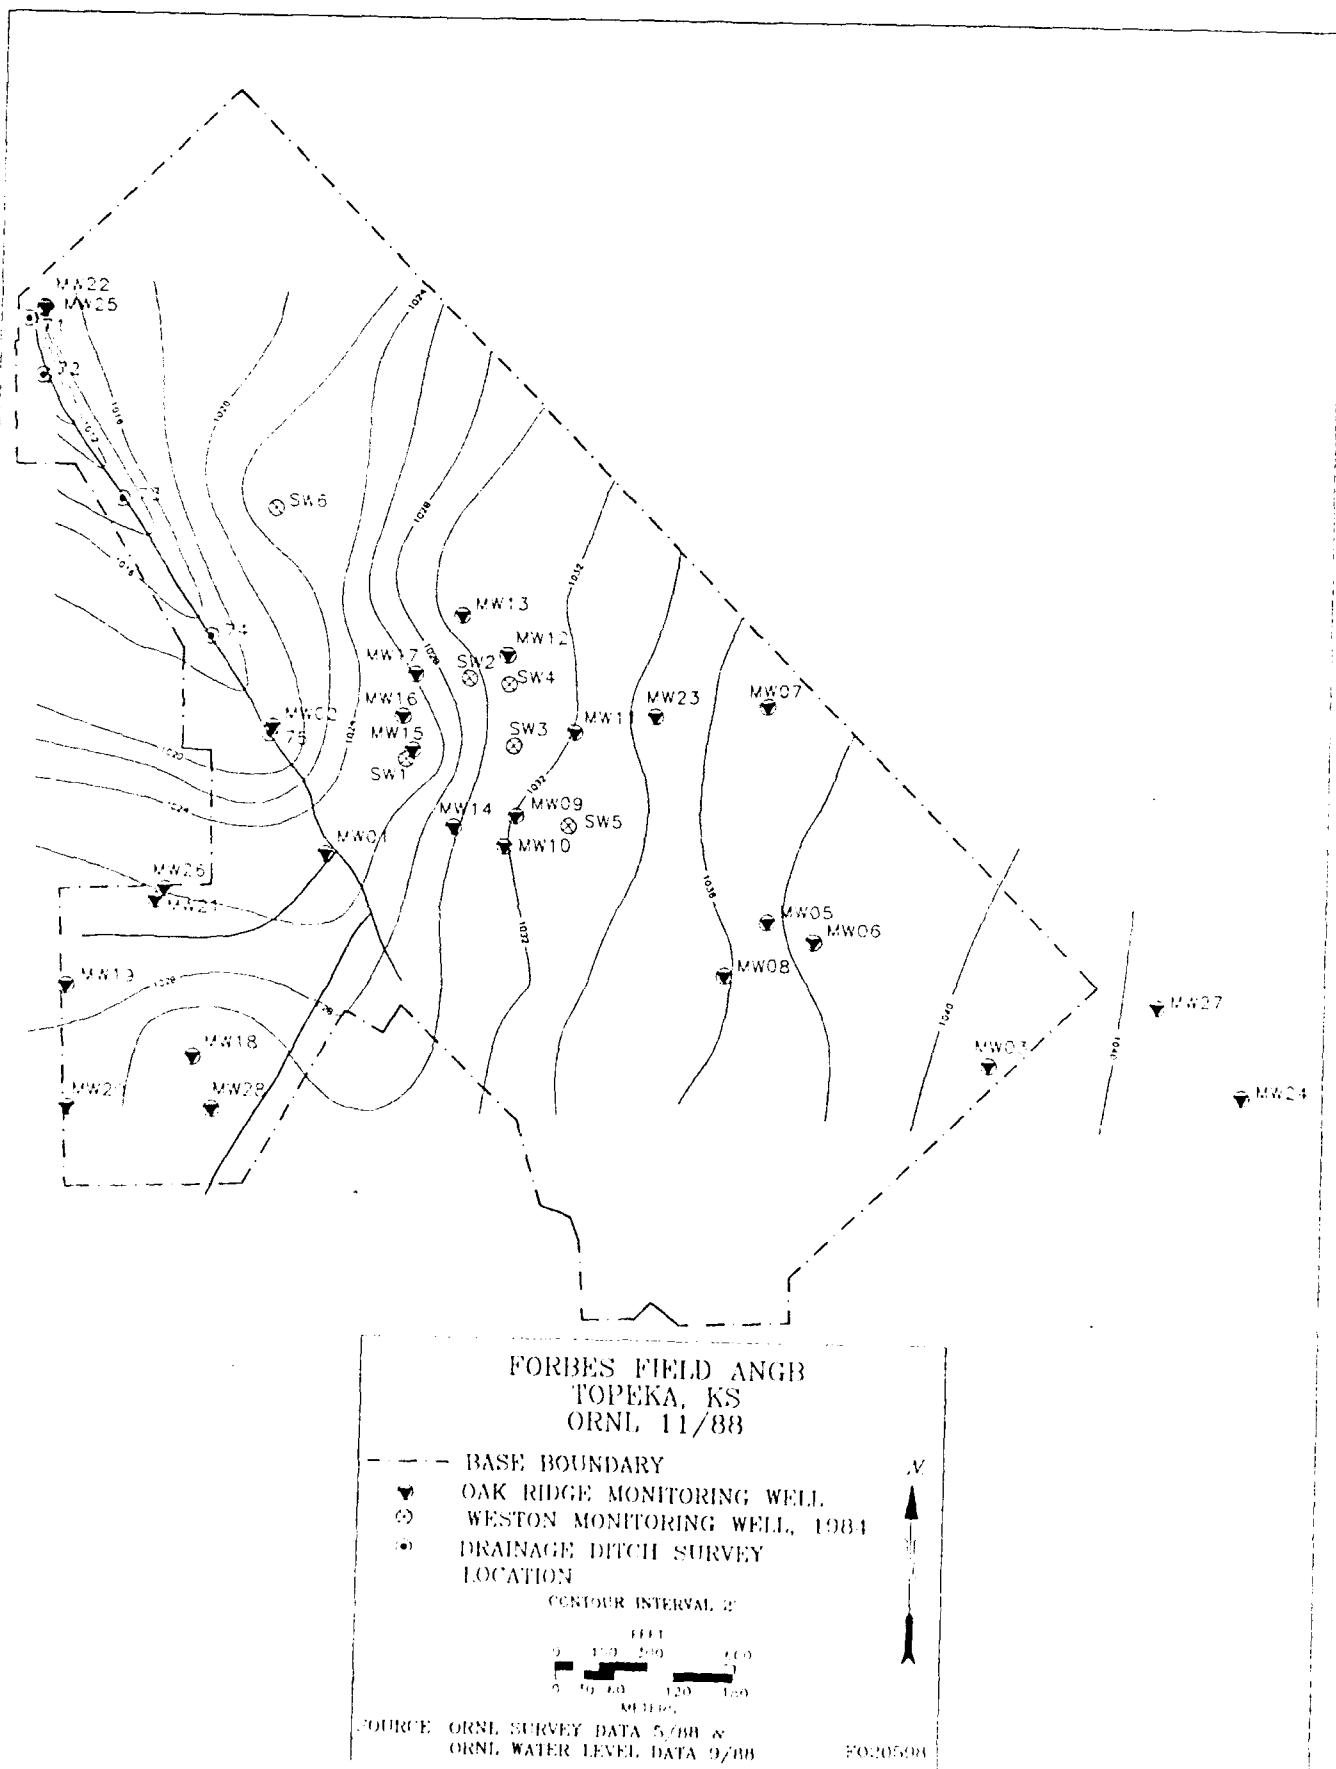
Fig. 2.13b. Potentiometric map of the unconsolidated aquifer water levels measured in September 1988.

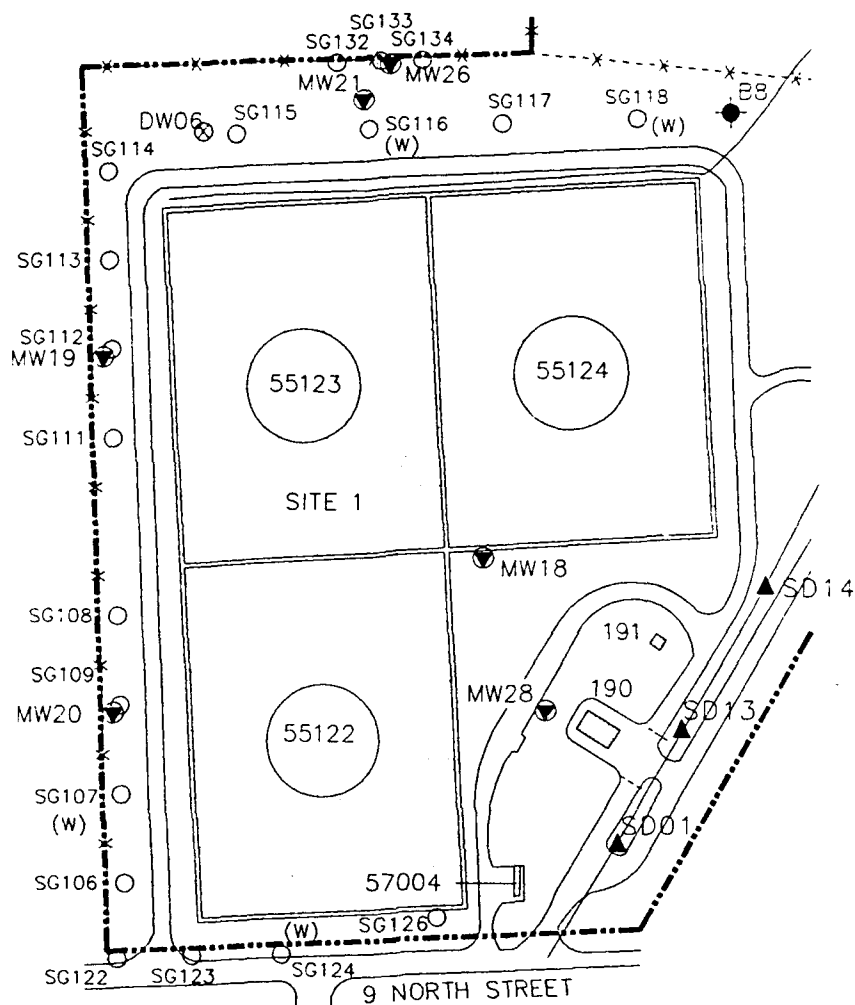
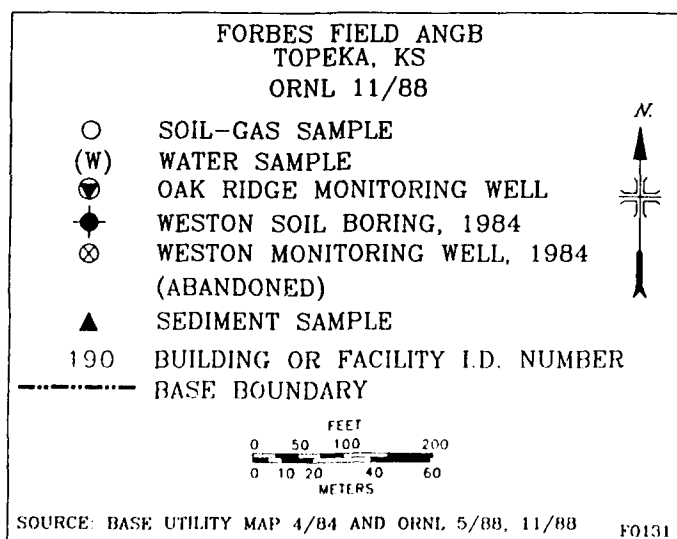
Fig. 3.1. Map of Site 1, tank farm.

Aerial photographs taken in 1954 show the tanks and the pumphouse in their present arrangement. During midsummer of 1981, a leak occurred in tank 55122--the southernmost tank. An estimated 1200 to 1400 gal of jet fuel leaked. The leak occurred on the southeast side of the tank within the diked area. The fire department sprayed foam over the fuel, and no fuel was recovered. Fuel which did not evaporate was adsorbed by the soil.

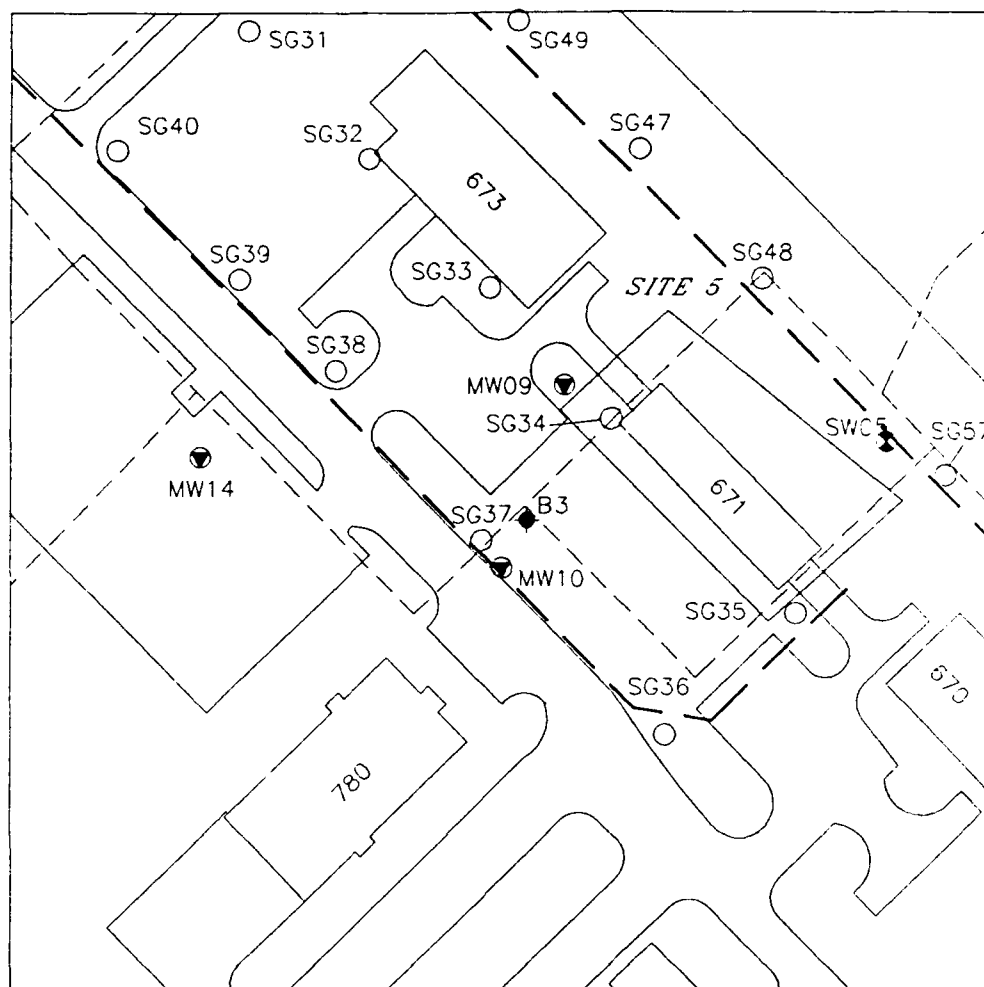
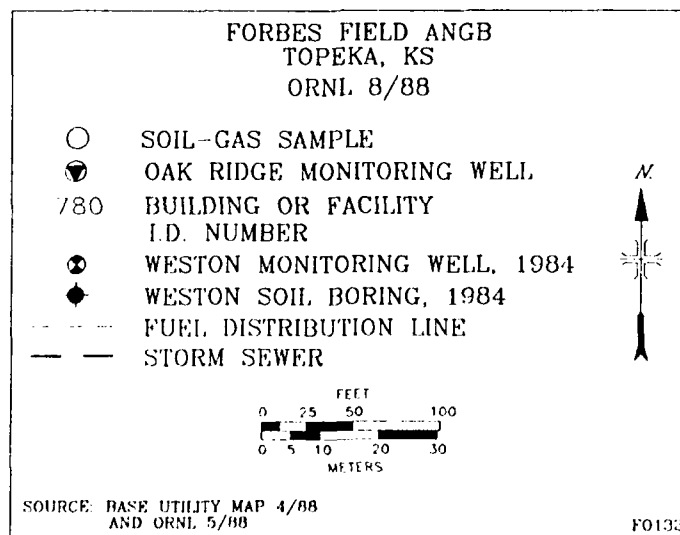
Fig. 4.1. Map of Site 5, pumphouse E.

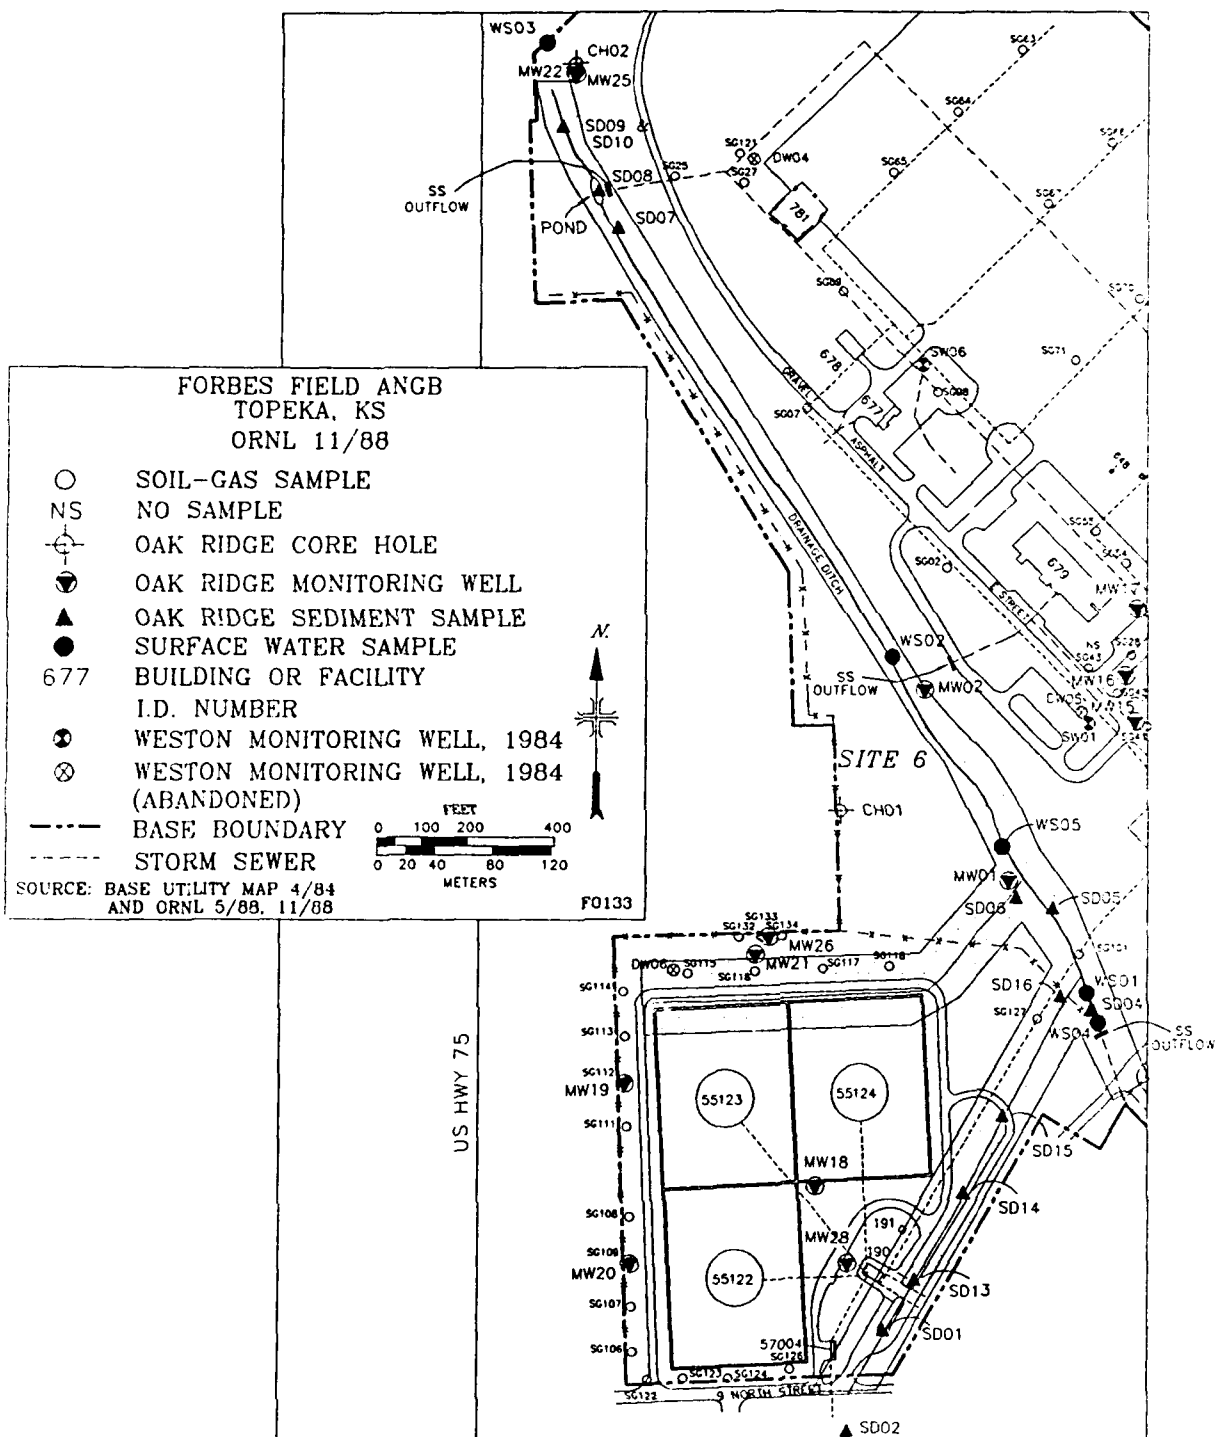
Fig. 5.1. Map of Site 6, surface drainage ditch and storm sewer outflow.

Storm runoff enters the ditch through a system of storm sewers and by direct surface runoff. Most of the base, including all of the aircraft parking ramps, hangars, and roads, drains through the storm sewers. The storm sewers drain into the ditch at three major locations. The largest of these is the outflow at the northwest corner of the base; this storm sewer drains all of the aircraft parking ramp and most of the parking lots and roads near the ramp. The outflow is a 6 ft square concrete culvert which empties into a

small basin at the northwest corner of the base. This basin is a depression in the ditch with an average depth of 1 ft and a total surface area of about 3000 ft². The basin is created by a small dam which increases the stream gradient approximately two feet. This basin is called "the pond."

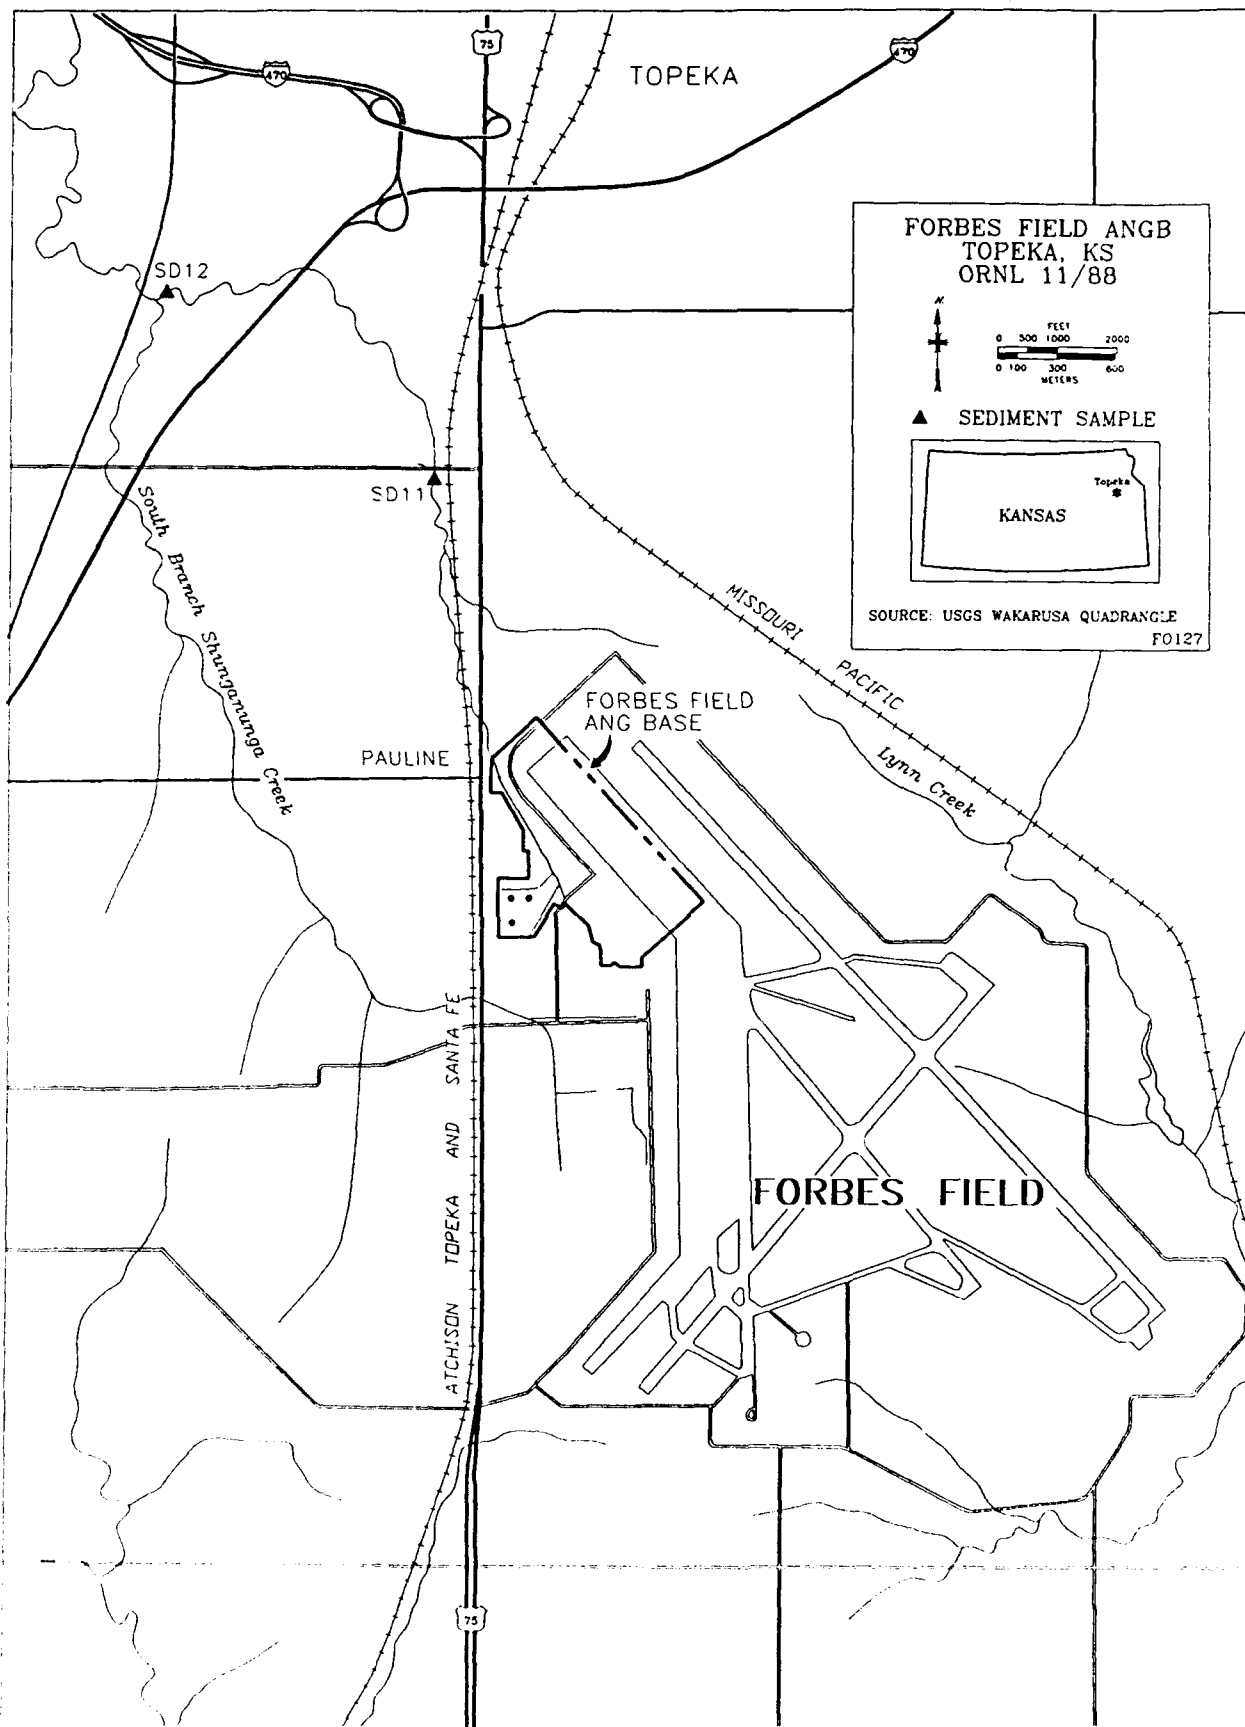
Fig. 5.2. Location of downstream sediment samples.

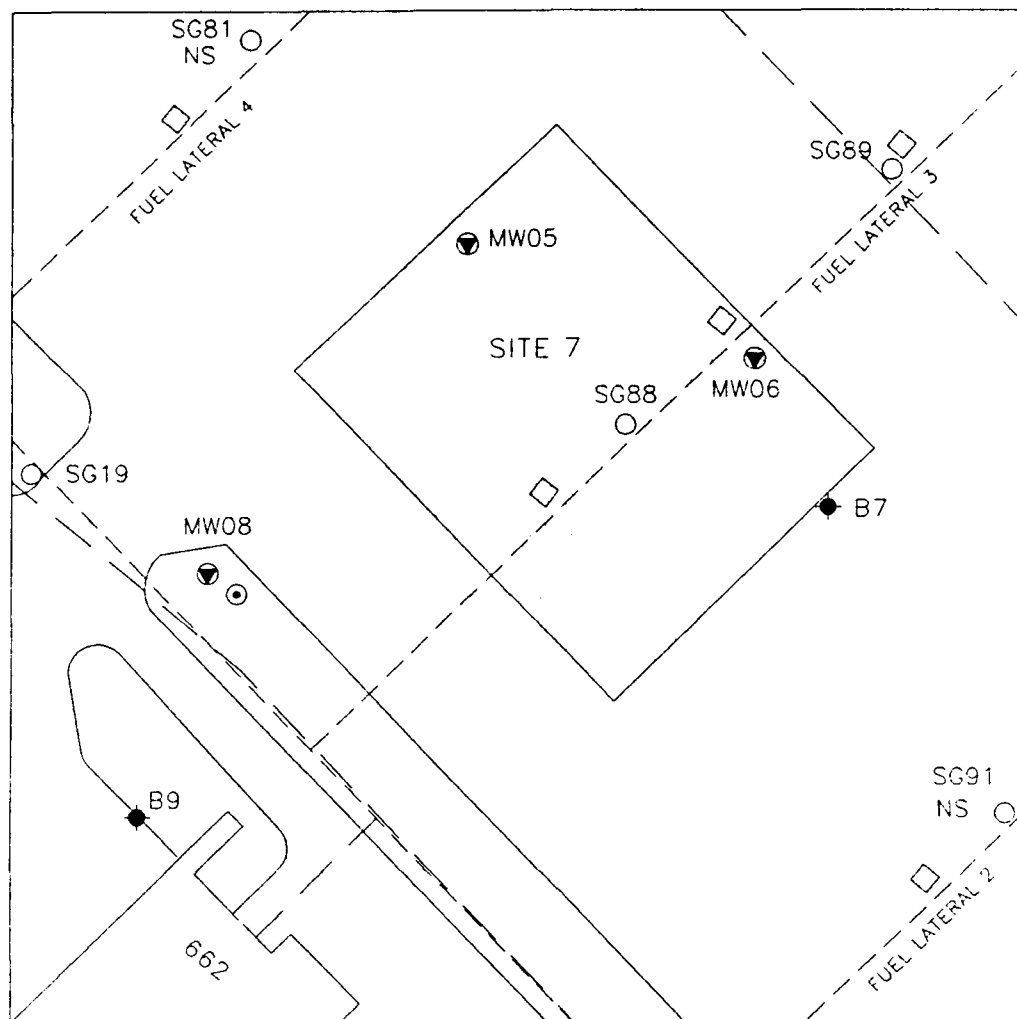
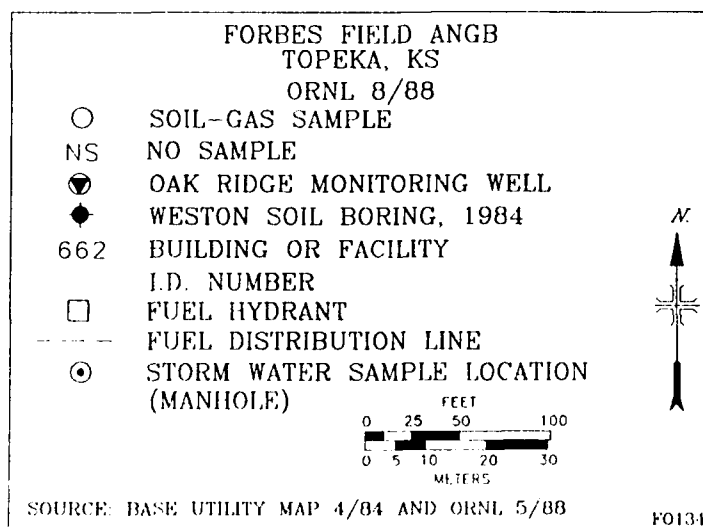
Fig. 6.1. Map of Site 7.

An undetermined amount of jet fuel leaked from the fuel hydrant at Site 7 in December 1981. Fuel lateral 3 is still in use.

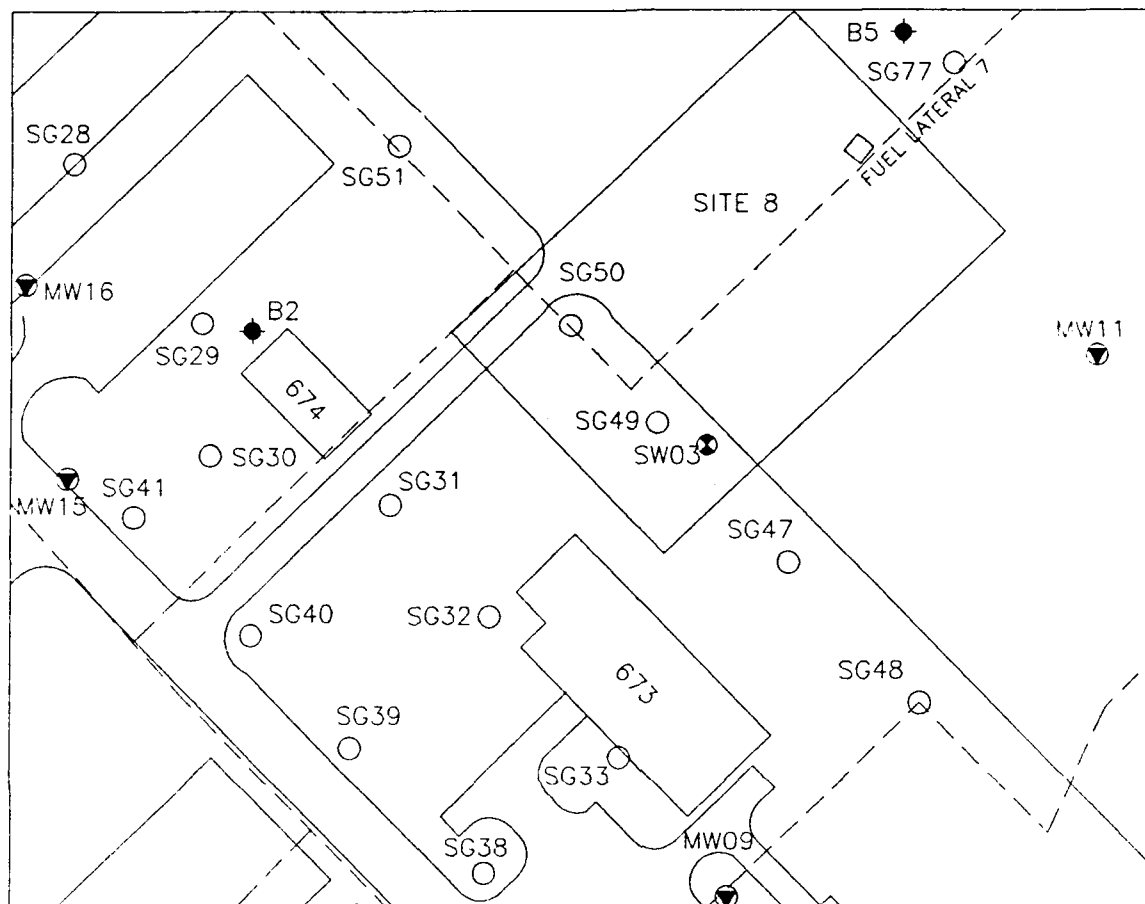
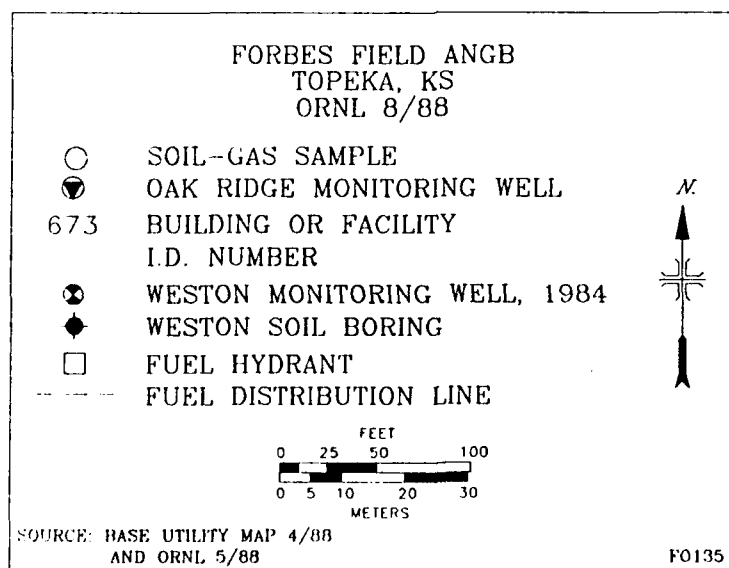
Fig. 7.1. Map of Site 8.

An undetermined amount of jet fuel leaked from the fuel hydrant at Site 8 in July 1982. Fuel lateral 7 is still in use.

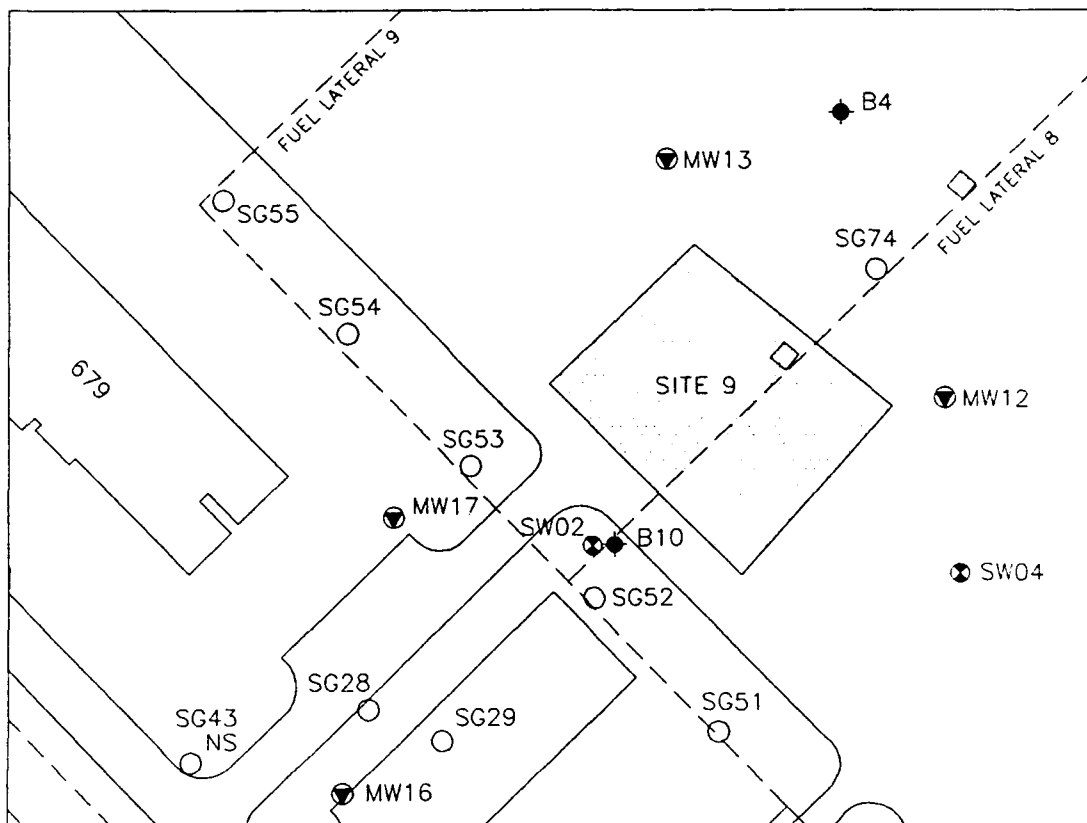
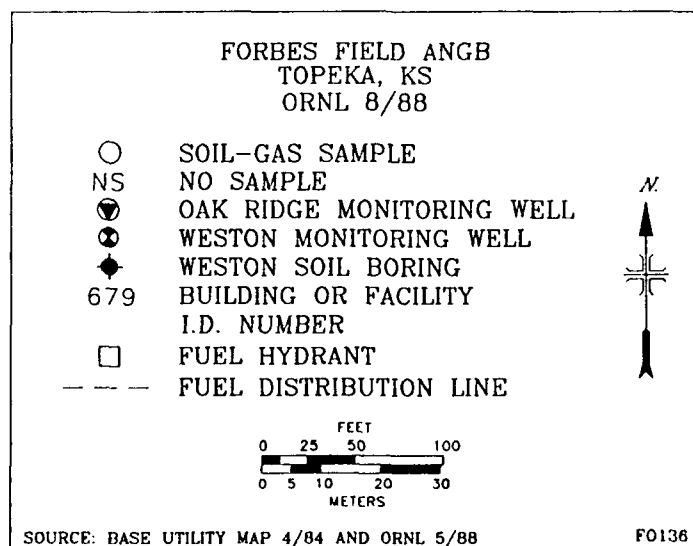
Fig. 8.1. Map of Site 9.

According to the Phase I records search, the largest spill from any of the fuel hydrants was thought to have occurred at Site 9 in 1983. The spill involved the loss of up to 3000 gal of JP-4. Discovery of the leak came when someone observed JP-4 emanating from pavement joints adjacent to Site 9. During pressurization to locate the leak, an unknown quantity of JP-4 escaped under the concrete pad. Subsequently, the fuel migrated to a storm sewer catch basin at the northwest corner of the base. The storm sewer drains into the ditch (Site 6) at the small ponding area. Fuel lateral 8 is still in use.

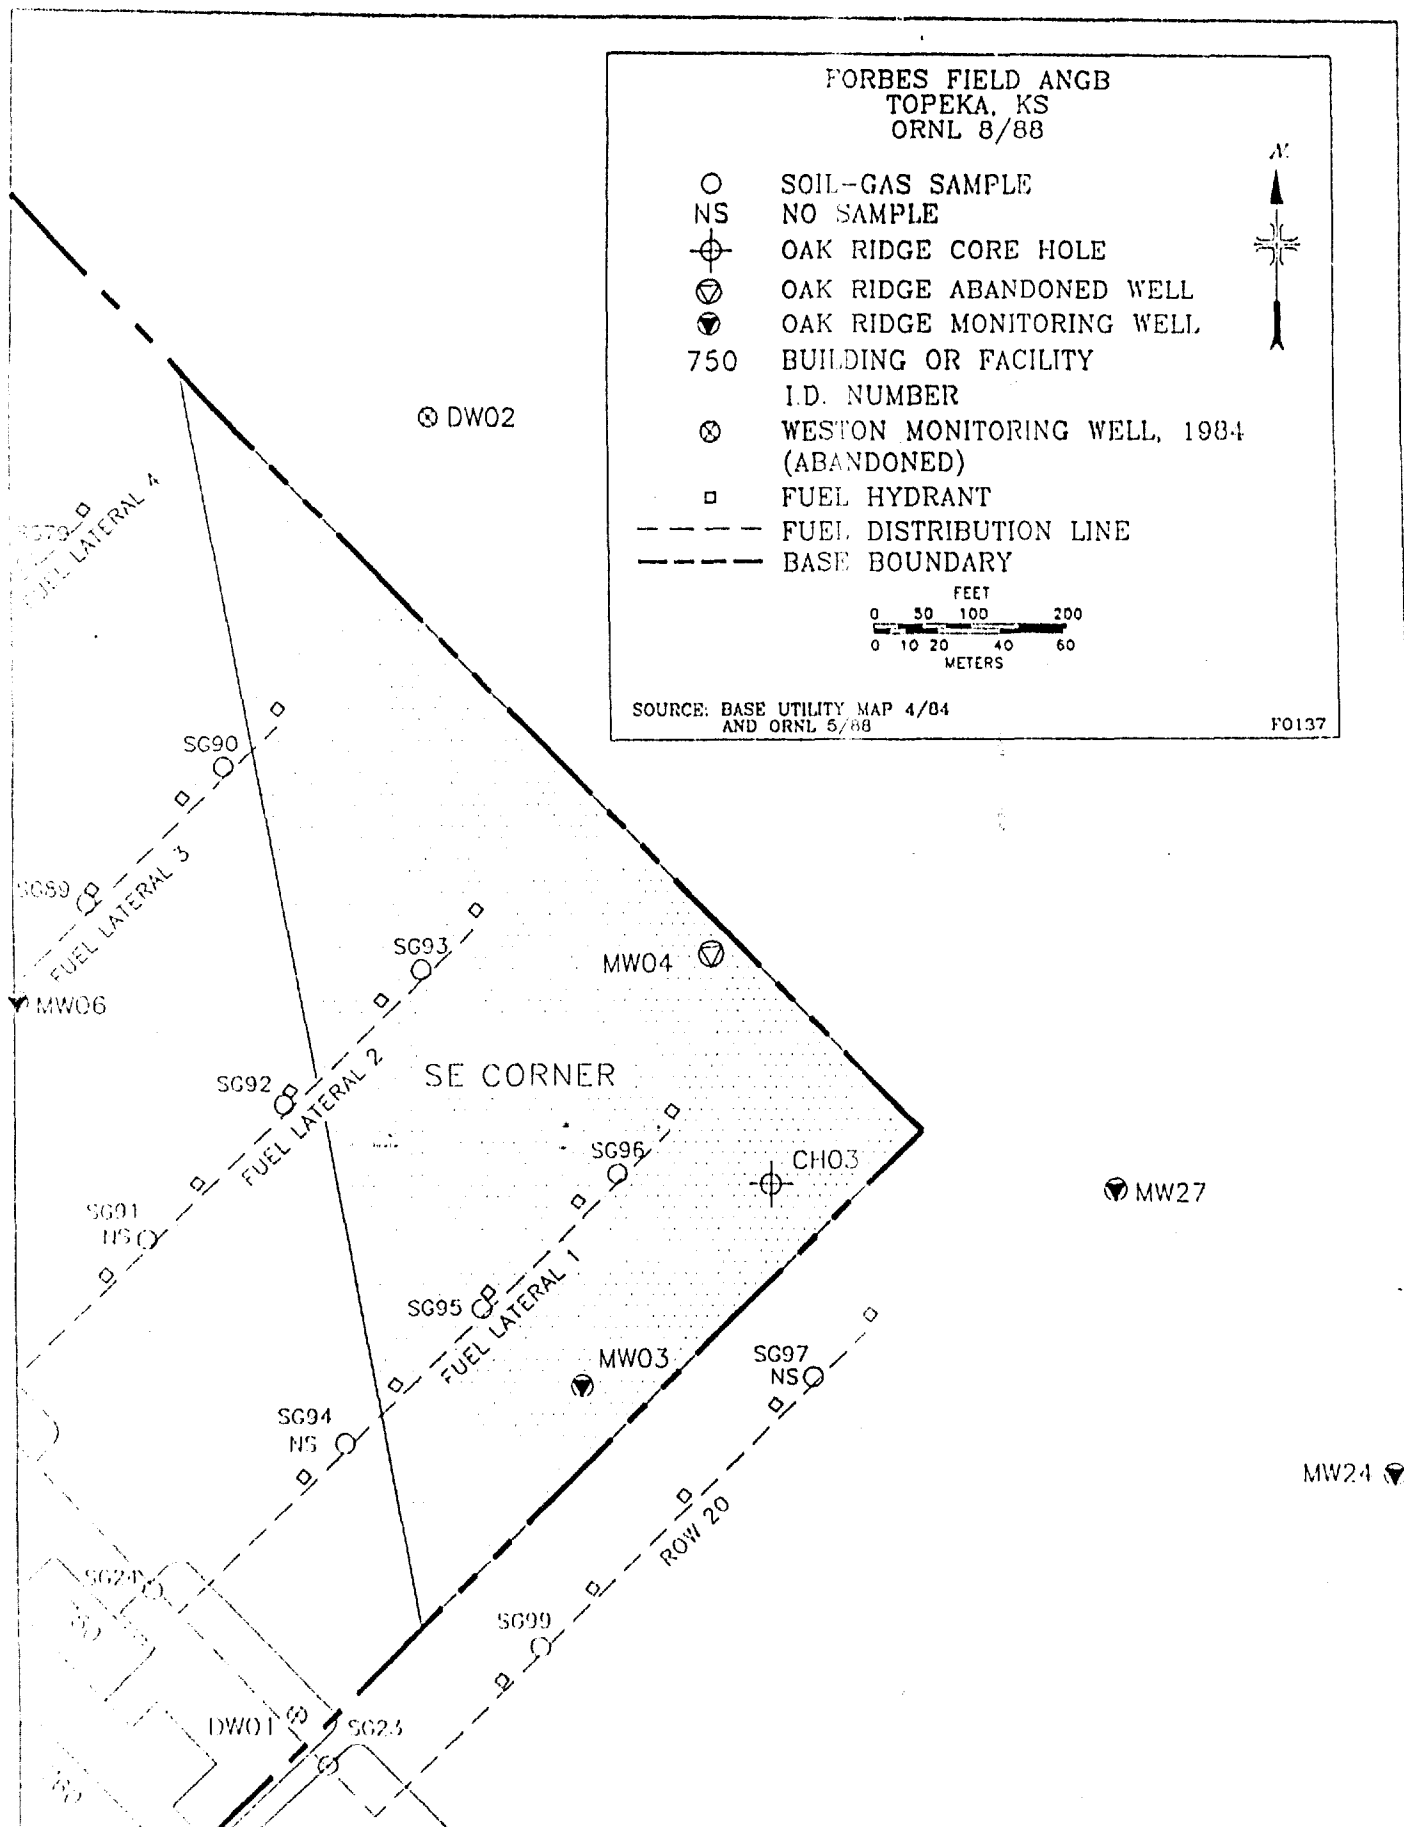
Fig. 9.1. Map of the southeast corner of Forbes Field ANGB.

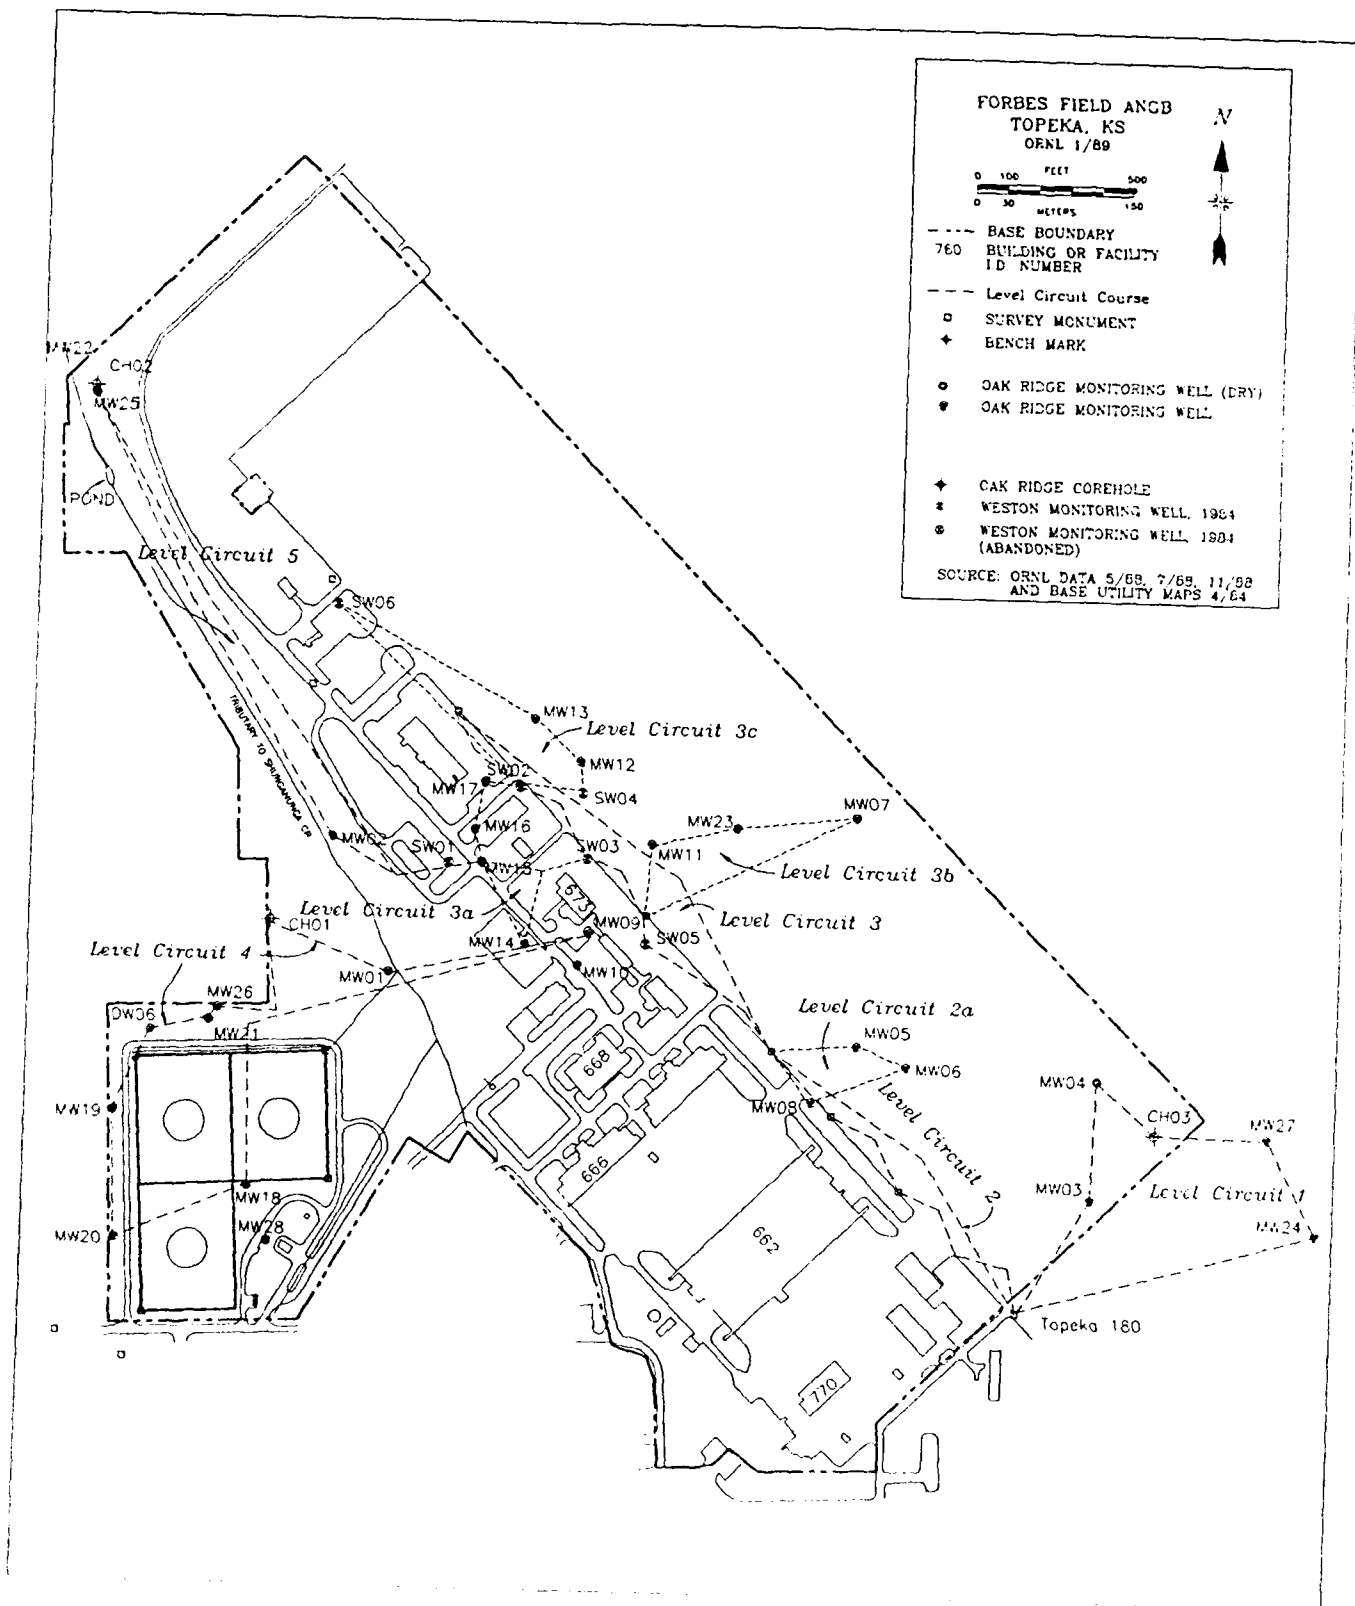
Fig. I-5. Elevation level loops.
